Master Builder

Project overview

Medium Renovation Project – Coldwells Building Company Ltd, Scotland

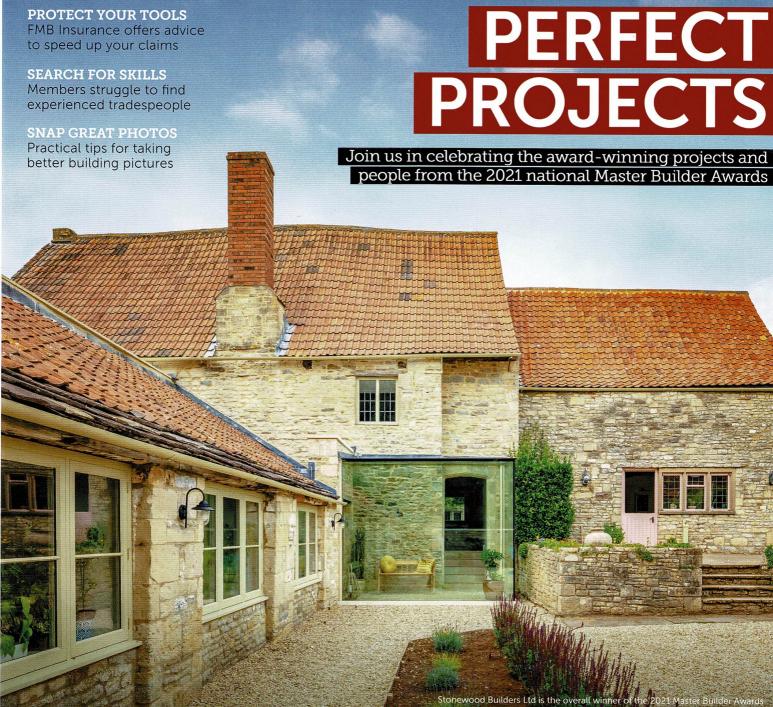
Coldwells Building Company Ltd won the award for a sensitive refurbishment in Aberdeenshire.
